A Study on the Impact of Hydrocarbon Contamination on Electrofusion Joints

Connor Cooper (Kinectrics), Michael Sabatini (Enbridge)

CGA Energy Nexus & Annual Technical Conference 2025

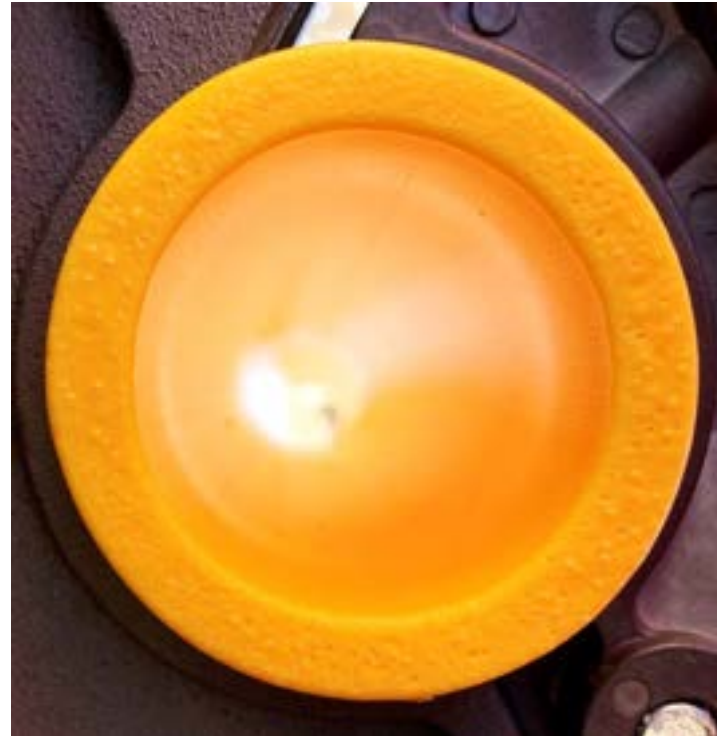
Pock-marking on cross-section of contaminated pipe with pock-marks formed during melt test

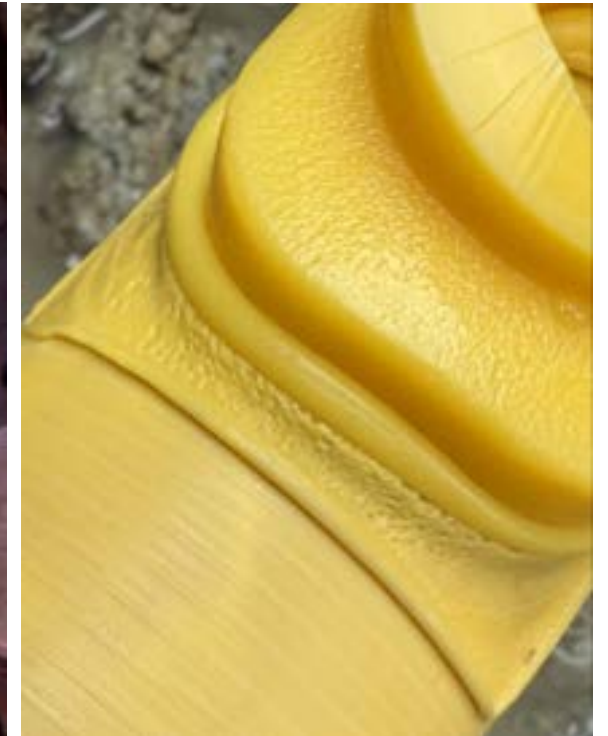
Pock-marking in fusion zone formed during conventional saddle fusion

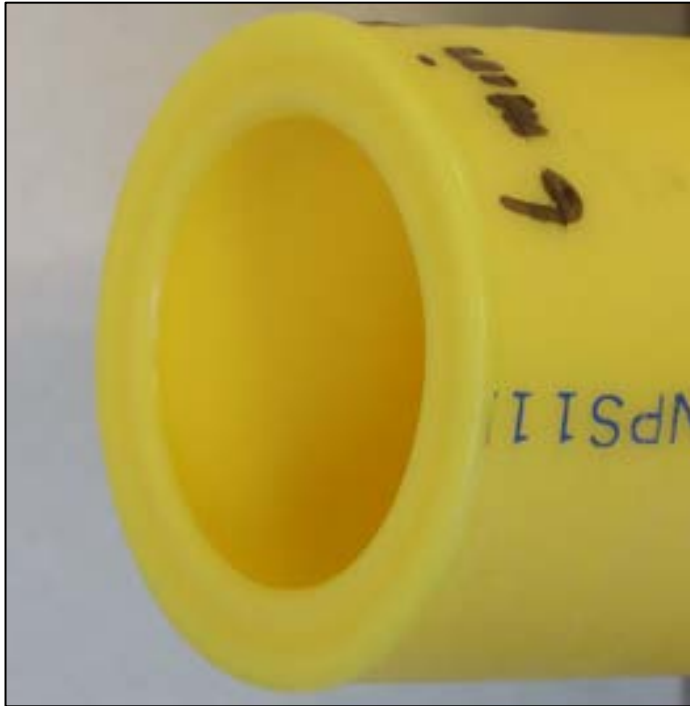
Immersion in Diesel

None

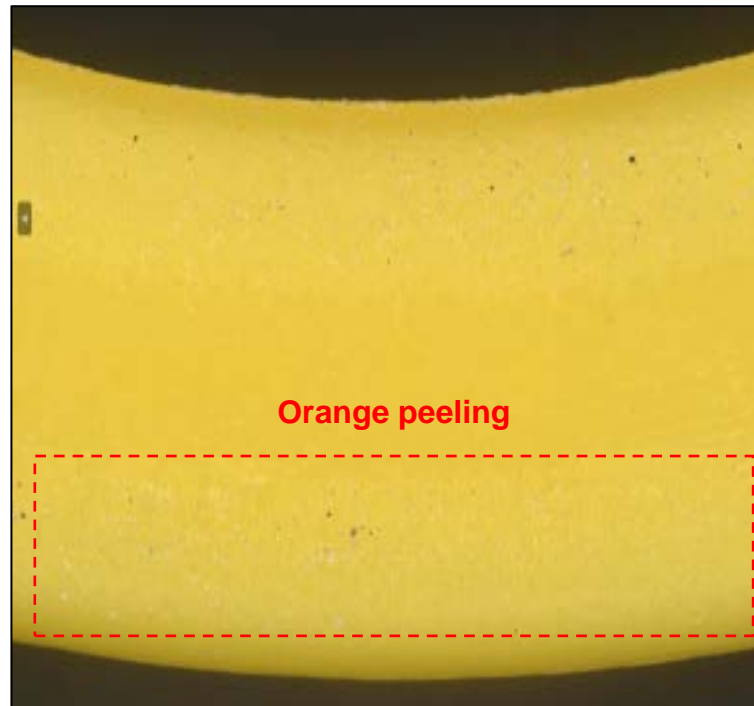
Immersion in Nonane

Minor

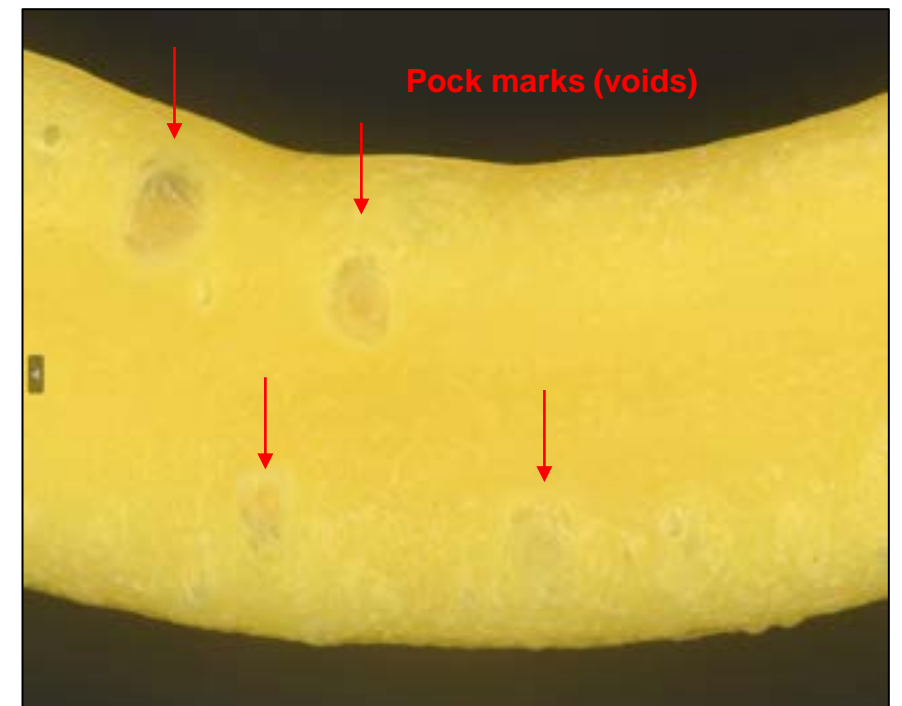
Immersion in Propane

Aggressive

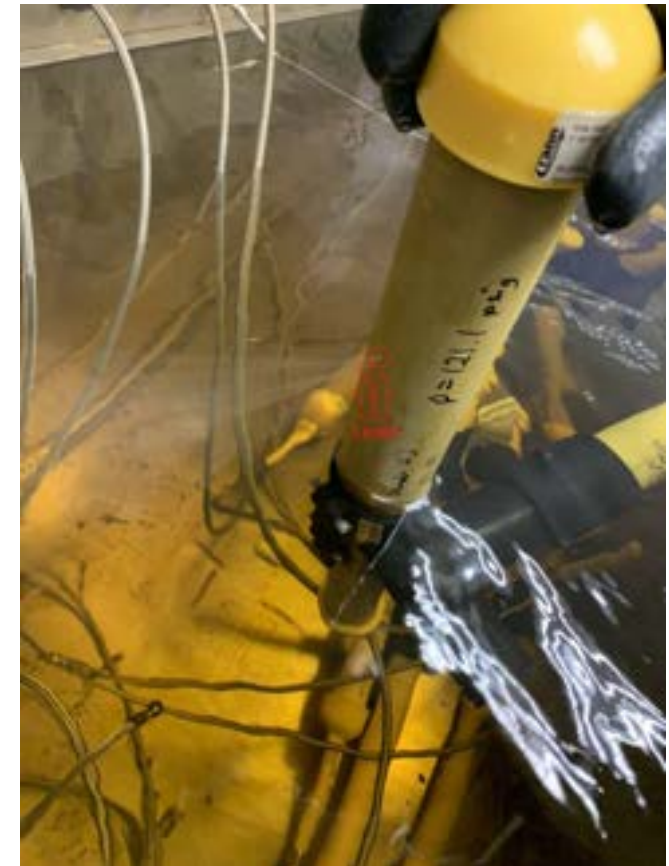
- Tested in accordance with CSA B137.4.1
- Samples were pressurized to 120 psi at 80°C
- For joints fused to contaminated plastic the pipe was the point of failure for all the field samples and materials tested
- Indicates that electrofusion to contaminated pipe does not compromise joint integrity

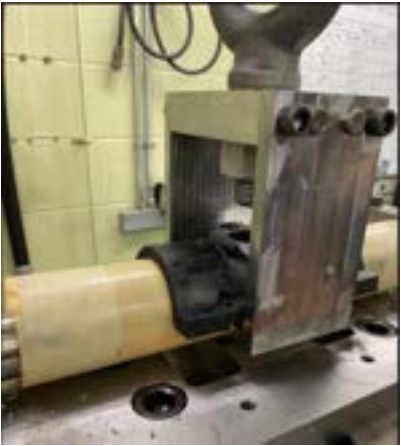
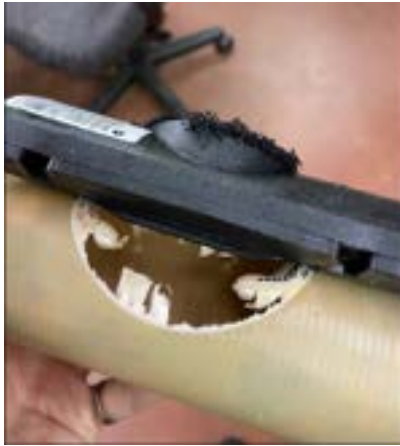
- Tested in accordance with ISO 13956-10
- For contaminated and non-contaminated pipe, fusion remained intact, pipe was the point of failure
- Indicates that electrofusion to contaminated pipe does not compromise joint integrity

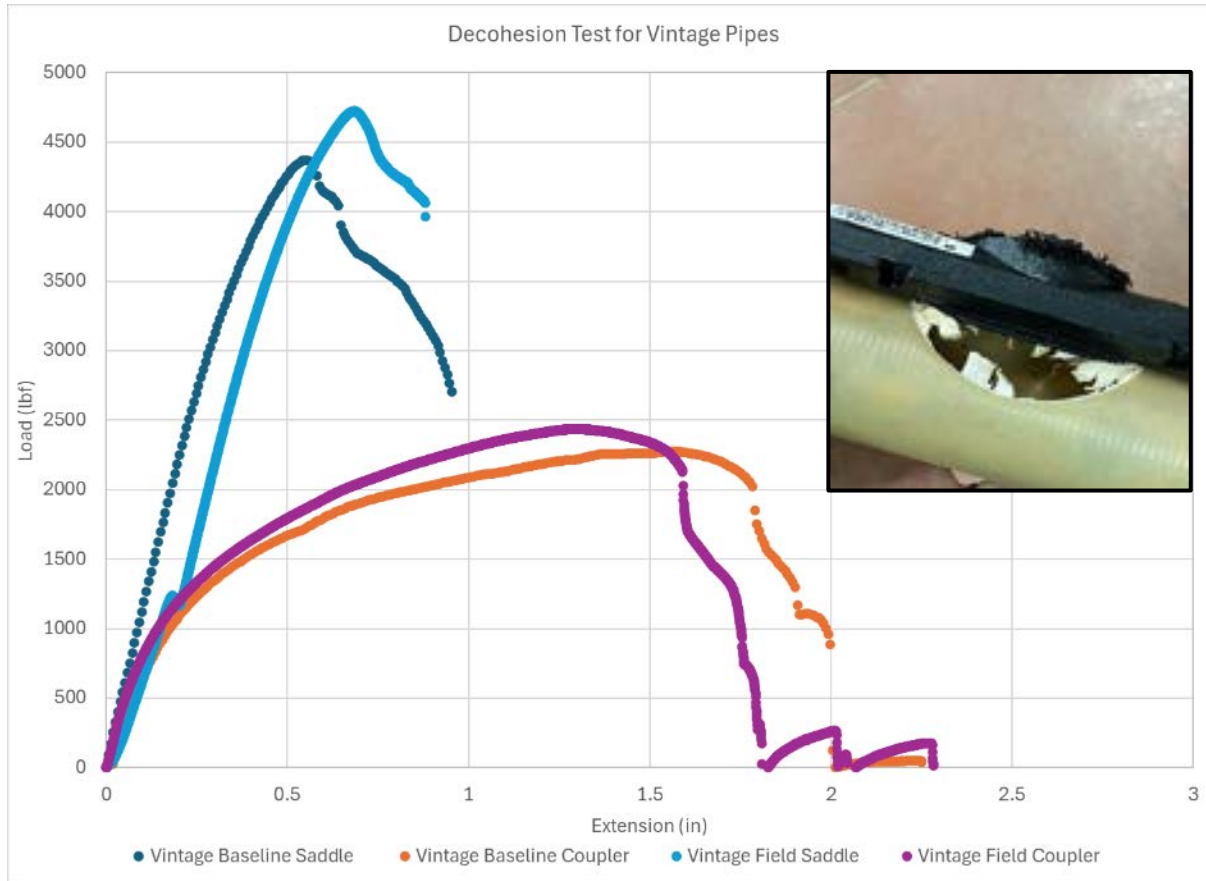
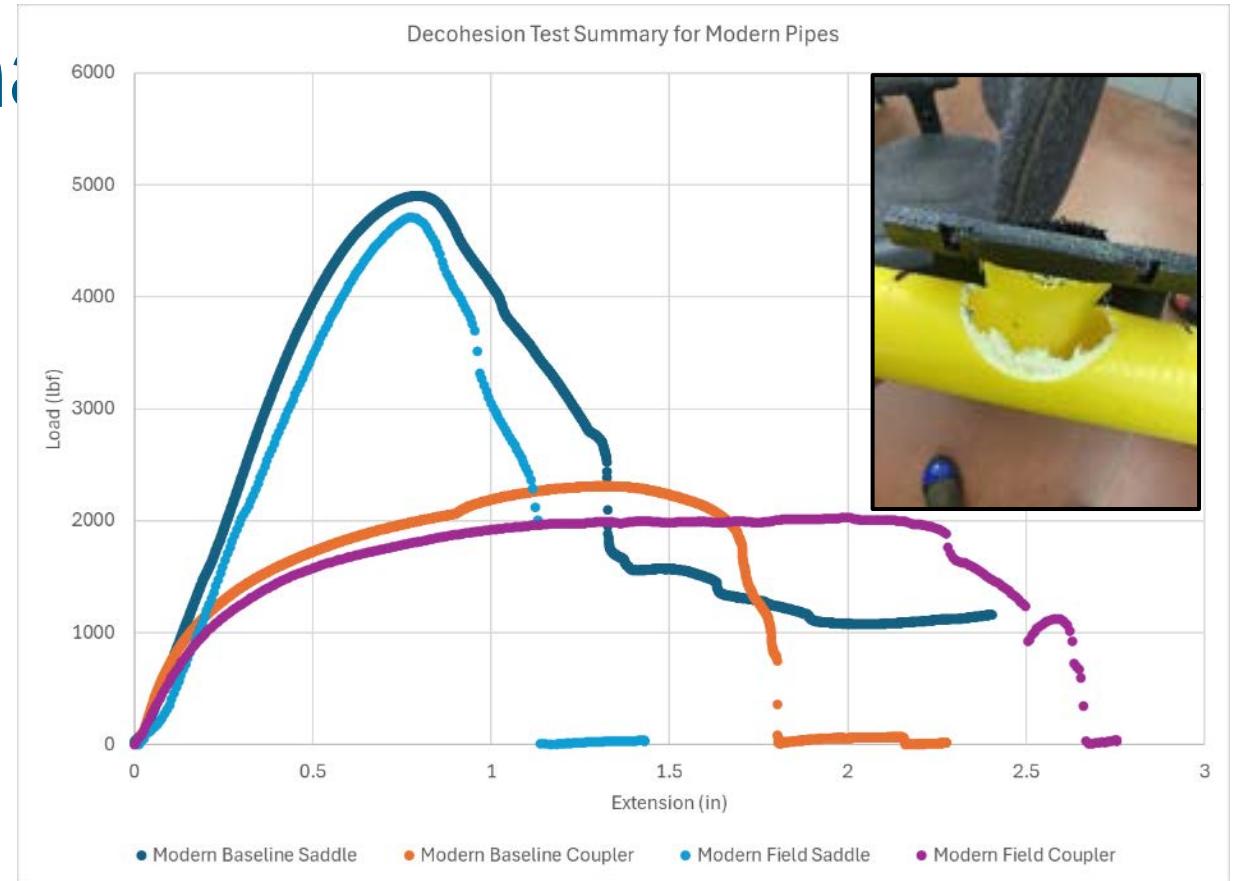
Custom decohesion rig produced repeatable failures for both saddle and coupler joints at the electrofusion joint interface.
