A Study on the Impact of Hydrocarbon Contamination on Electrofusion Joints

Connor Cooper (Kinectrics), Michael Sabatini (Enbridge)

CGA Energy Nexus & Annual Technical Conference 2025

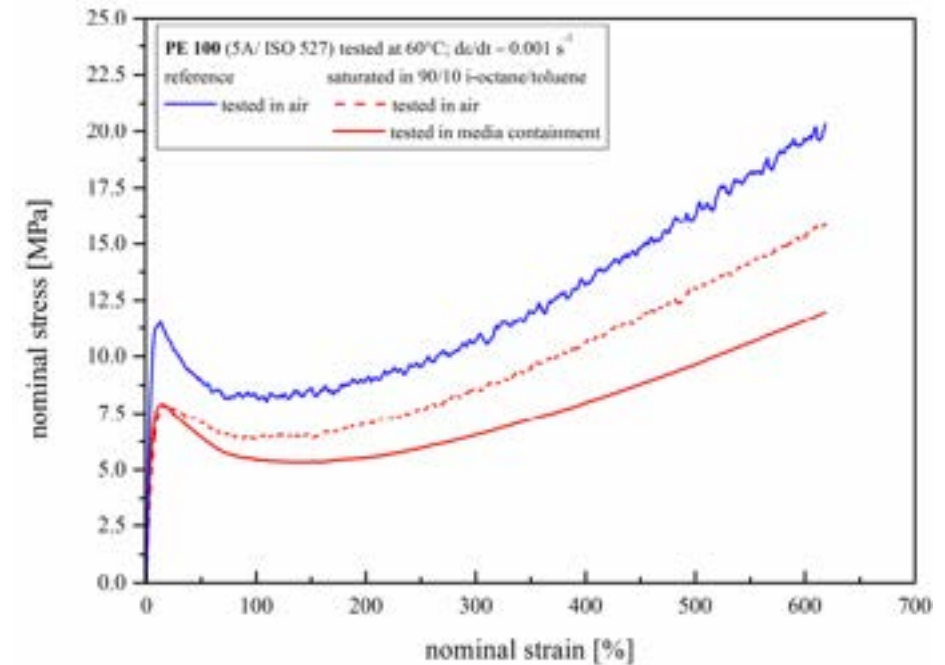
- Literature studies provide examples of how the mechanical performance of a PE pipe changes once exposed to liquid hydrocarbon contamination:
 - Schoeffl et al. demonstrated a decrease in axial and hoop yield stress of 35% - 50% after saturating PE samples in a mixture of octane and toluene
 - Kuryndin et al. demonstrated a 50% reduction of Young's Modulus as saturation increases
 - Crippen et. Al. demonstrated that the UTS in MDPE and HDPE is reduced following HHC saturation. Similarly significant strain reduction also occurs at low strains (<30%)

Nominal Stress / nominal strain curves of PE 100-2 comparing liquid hydrocarbon (LHC) fully saturated specimens tested either immersed in the LHC or in air, with a control provided as reference

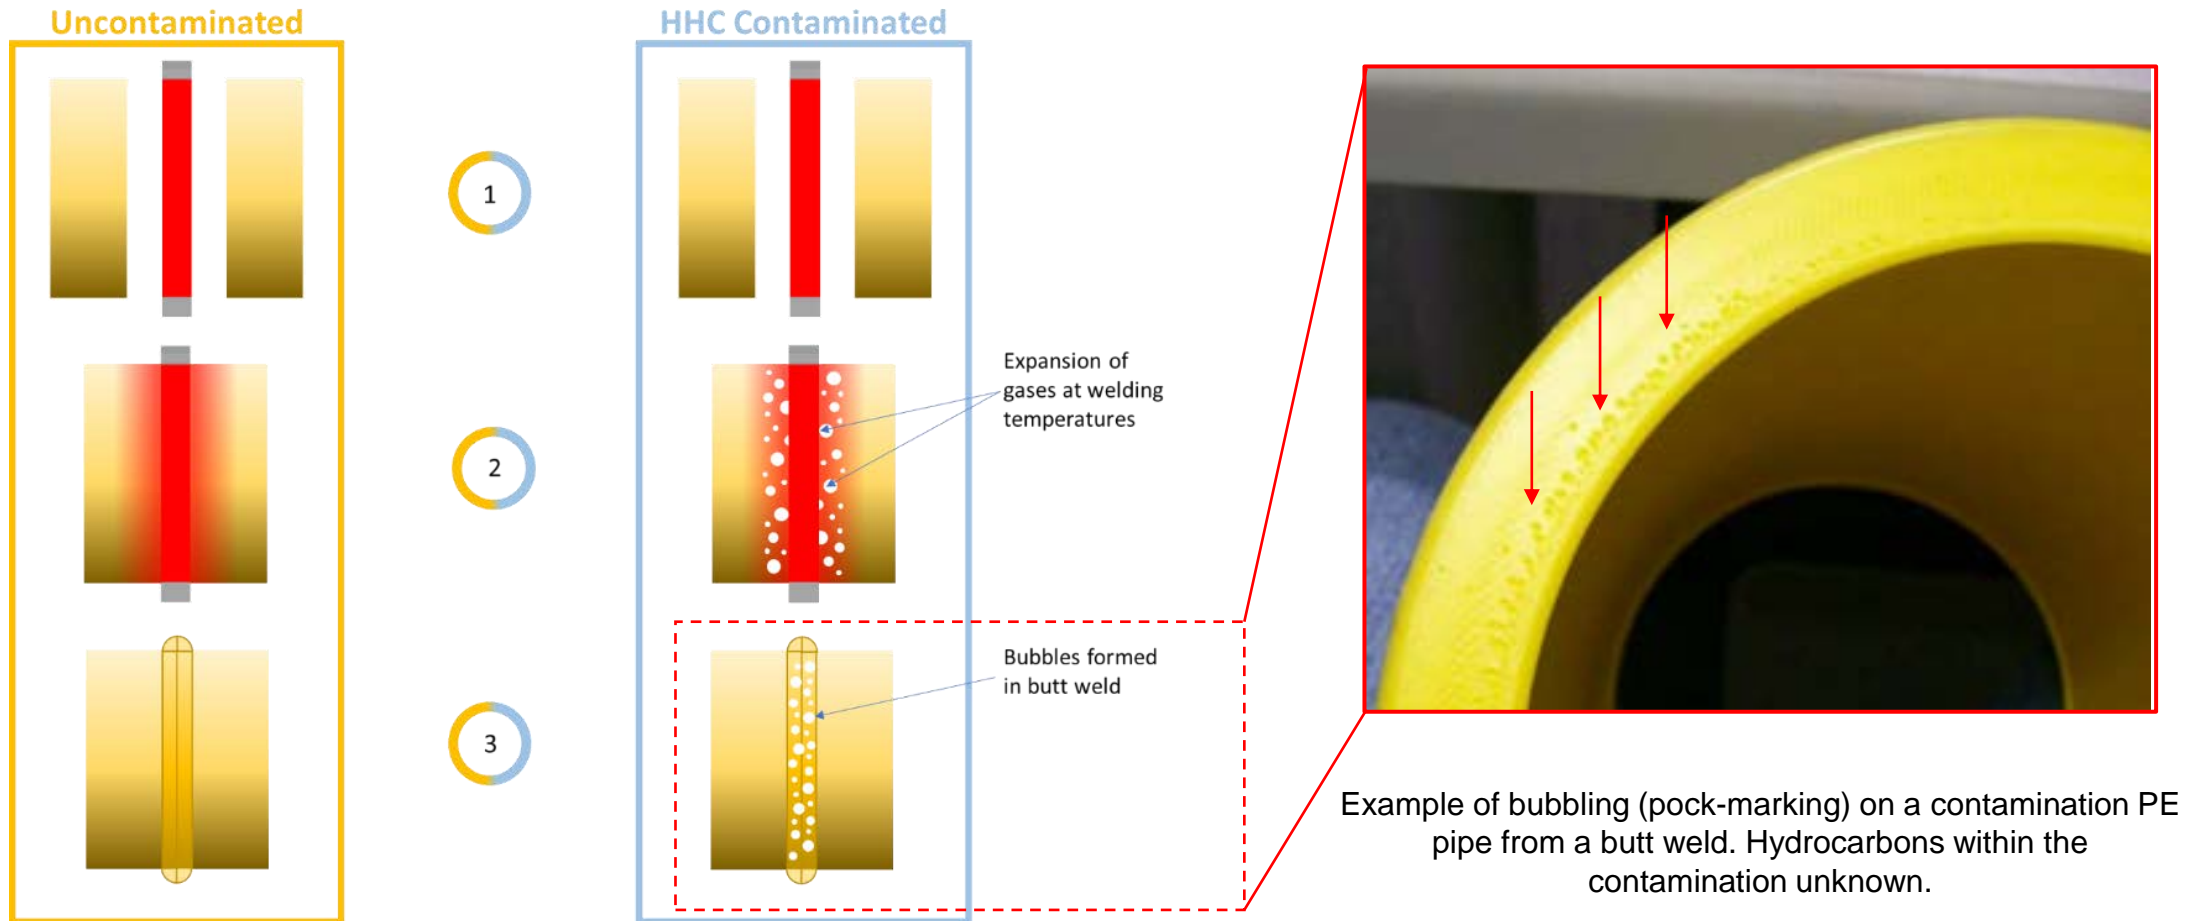
Schematic comparison of butt welds for uncontaminated and contaminated gas piping.

Expansion of
gases at welding
temperatures

Bubbles formed
in butt weld

Reduced expansion of
gases due to lower welding
temperature

Reduced bubbling,
distributed across
electrofusion weld region

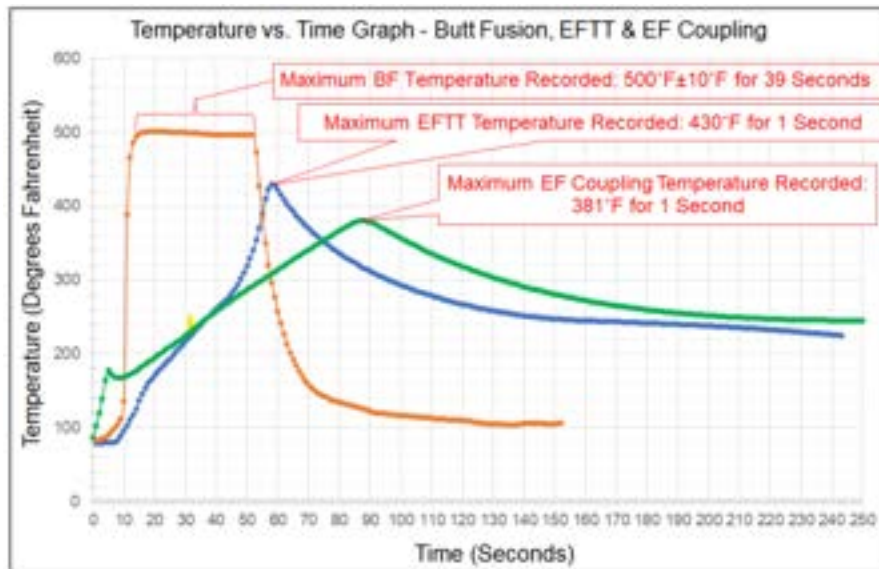
- In melt pattern gradient temperature tests ranging from 300°F to 500°F, pock-marking was observed to be more severe at high temperatures
- Pipe joined by conventional fusion sees temperatures of 500°F, for 39 seconds
- Electrofusion joints see temperature of 381°-430°F for 1 second

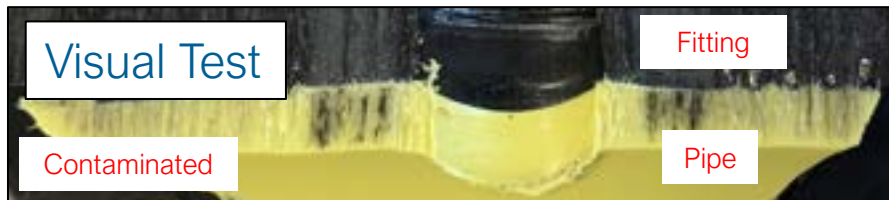
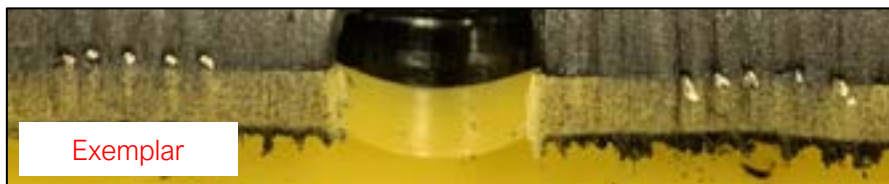
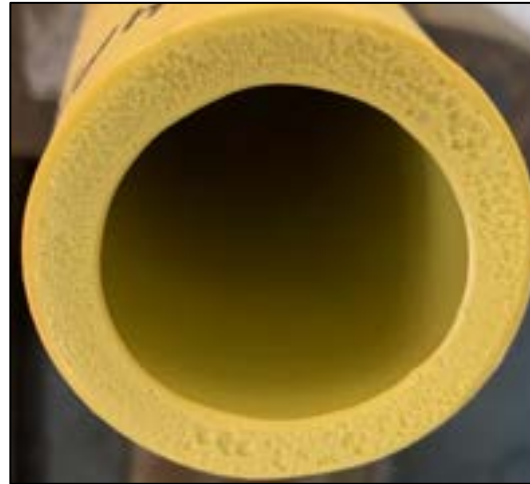
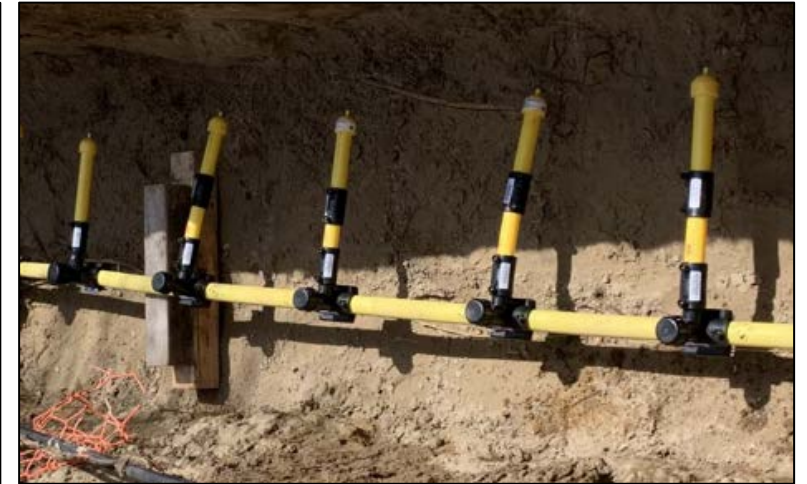
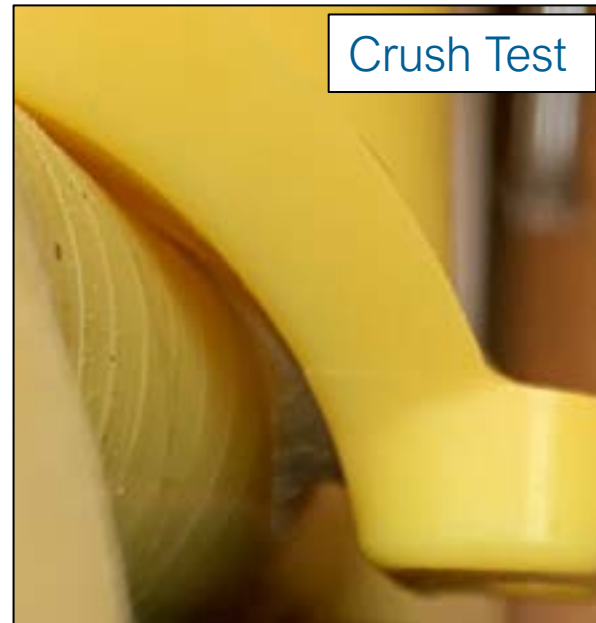
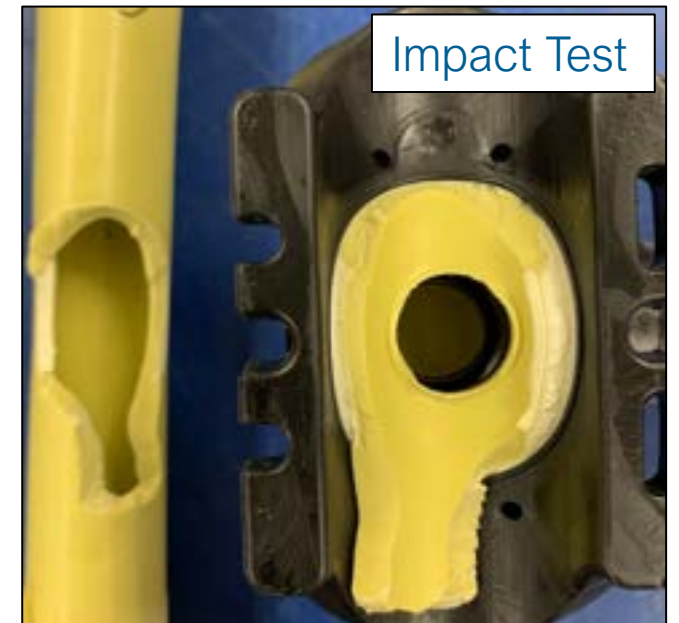
- Initial field testing took place at location of severe contamination in Greater Toronto Area (1980s vintage pipe)
- 20 electrofusion joints were evaluated for pressure testing, crush testing, impact testing, and visual inspection of fusion interface
- All samples passed the qualitative testing providing basis for current quantitative testing plan

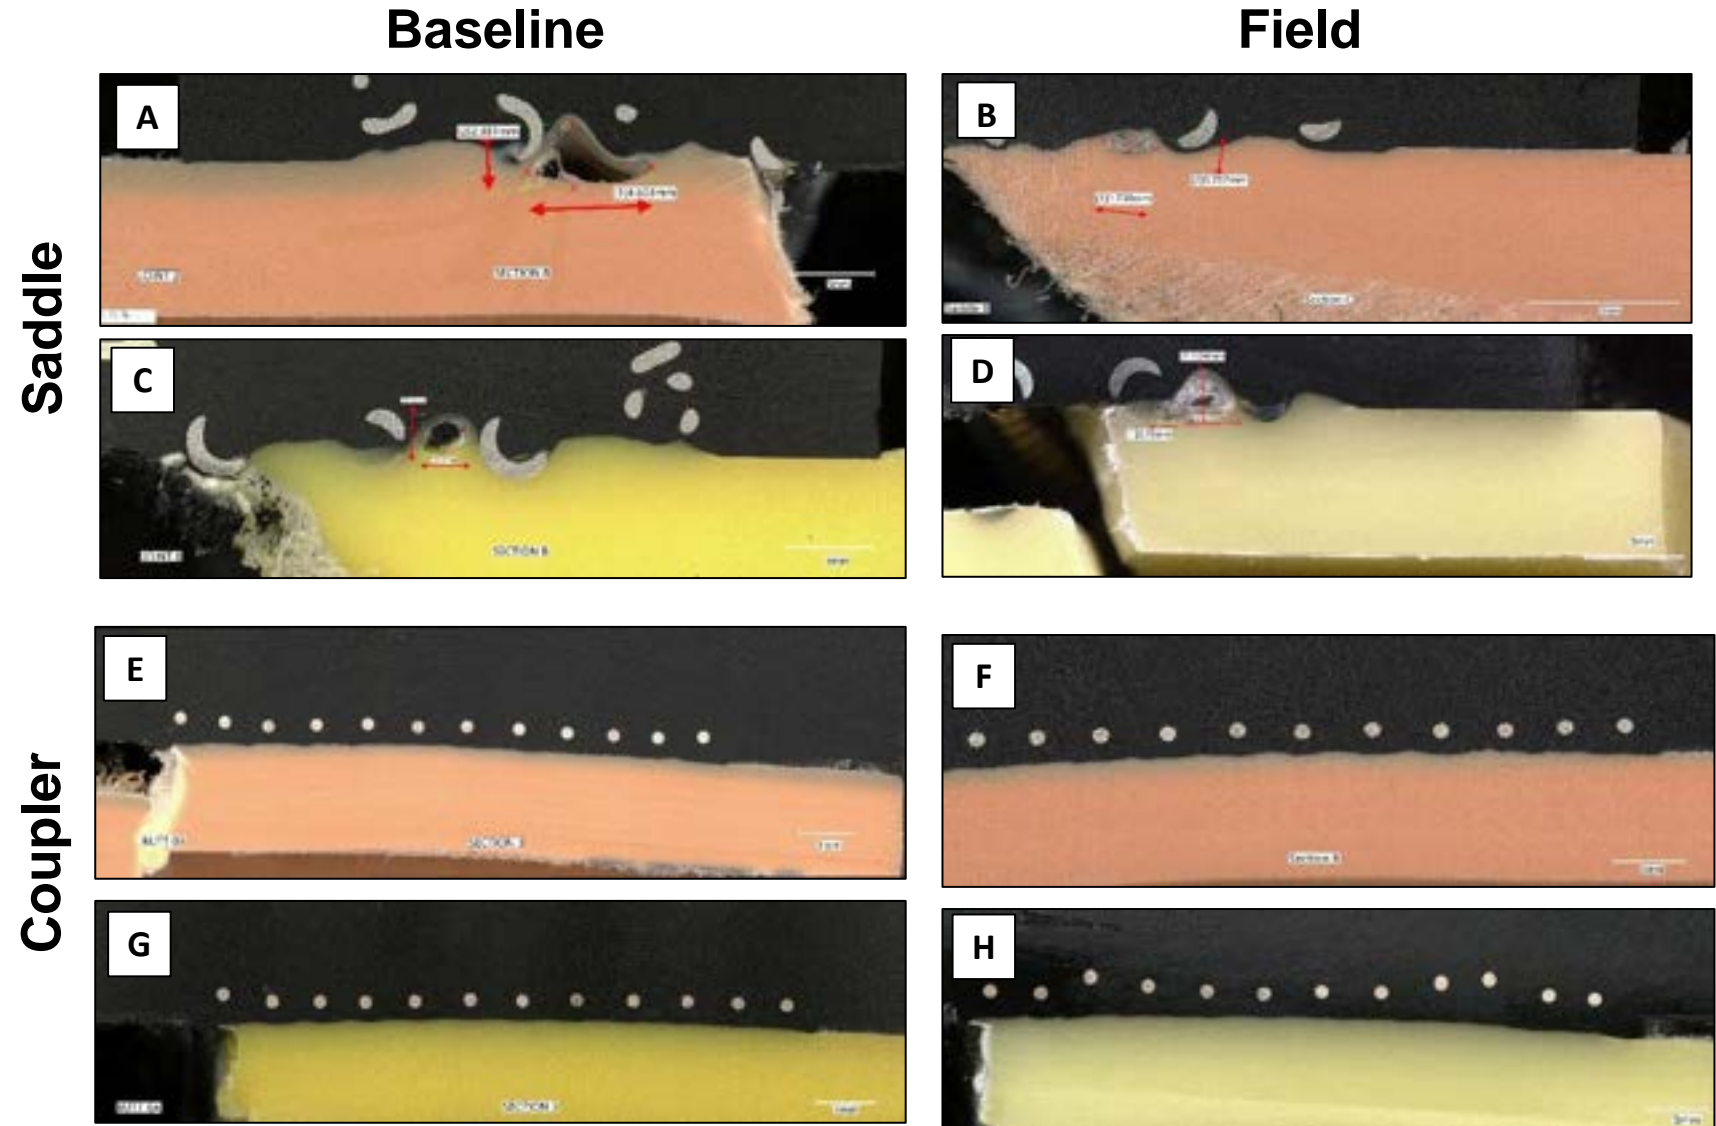
- Quantify percentage of voids (if any) at pipe/electrofusion fitting interface

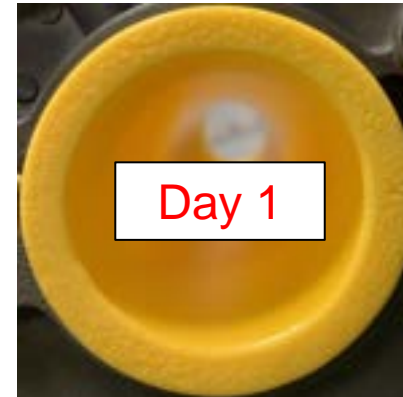
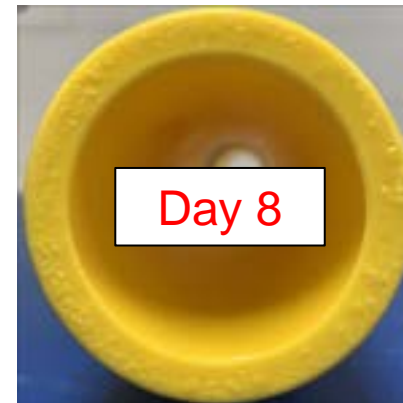
- Samples tested in accordance with CSA B137.0
- Preliminary testing of contaminated Yellow (Plexco PE2406) pipe indicates the material properties are stable and meets/exceeds specification

Test Time (Days After Pipe Removal)	Ring Tensile Strength (MPa)	Wall Thickness (mm)
1	22.2	5.79
2	22.2	5.80
4	21.3	5.80
8	22.1	5.80

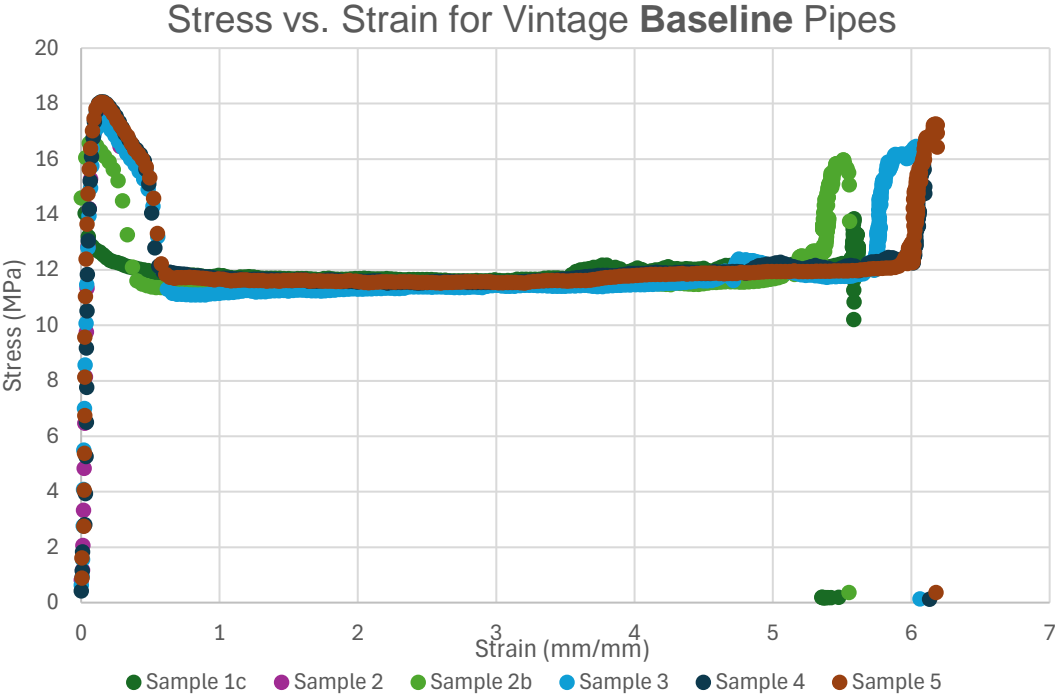
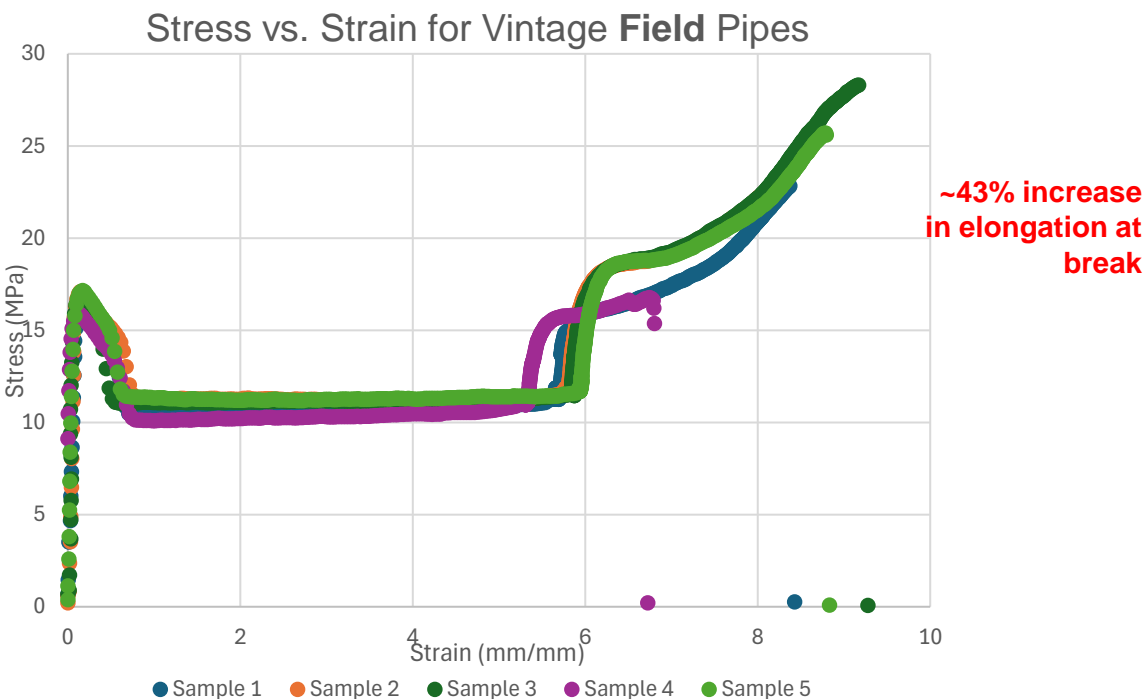
Sample ID	Average Extension at Break (%)	Average Stress at Break (MPa)	Average Stress at Yield (MPa)
Vintage Baseline	591 ± 30	17.57 ± 0.61	16.26 ± 1.62
Vintage Field	848 ± 99	24.16 ± 4.62	16.61 ± 0.61
Modern Baseline	747 ± 15	15.46 ± 0.40	21.12 ± 2.27
Modern Field	563 ± 24	11.37 ± 0.21	16.73 ± 0.16
